Situation Photo Log

Saturday, August 25, 2012 Kalamazoo River / Enbridge Spill

Prepared by: Matthew Haak START-USEPA Situation Unit Leader

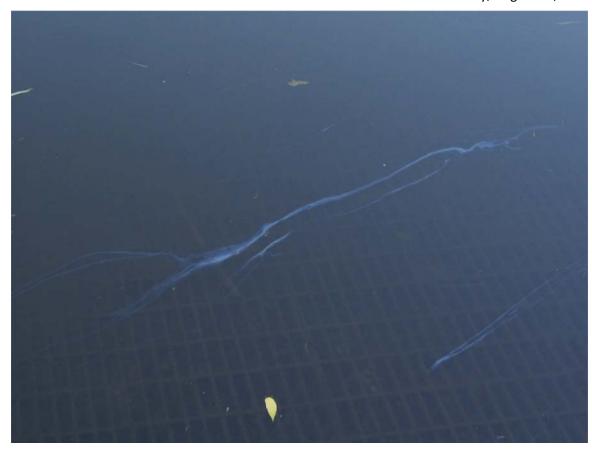
1. CO.4 Boat launch observed sheen and tar glob.

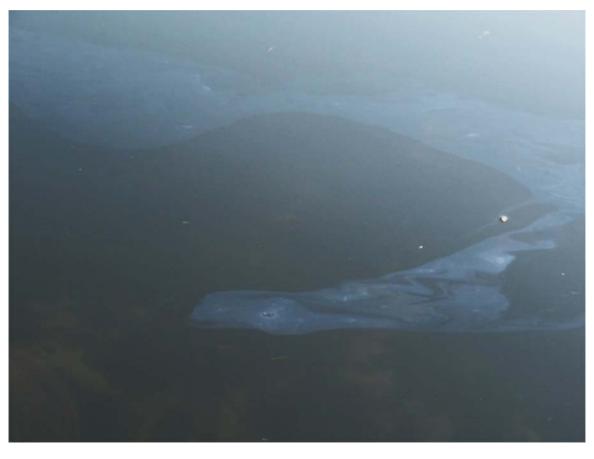
2. MP5.35 LDB observed sheen and tar glob.

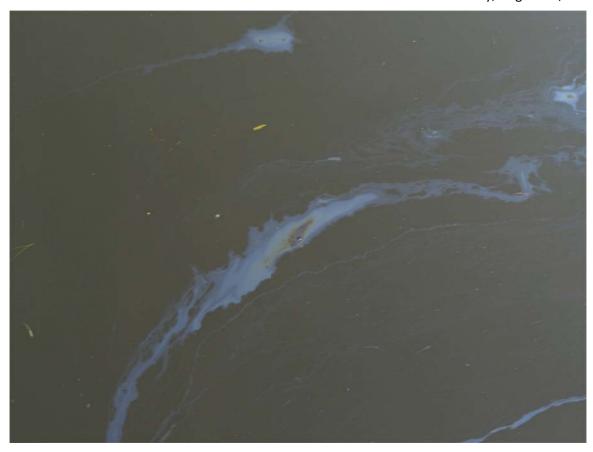
3. MP5.4 LDB sheen and tar globs observed.

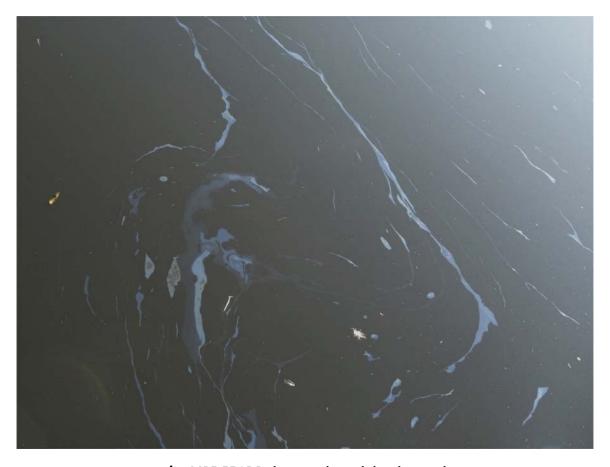
4. MP5.55 LDB sheen and tar globs observed.

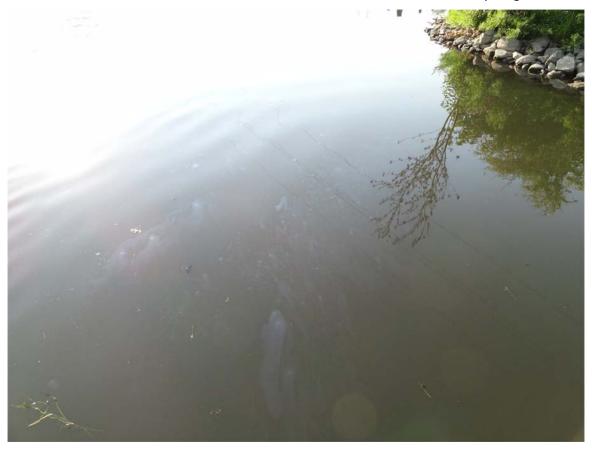
5. MP5.63 LDB sheen observed.

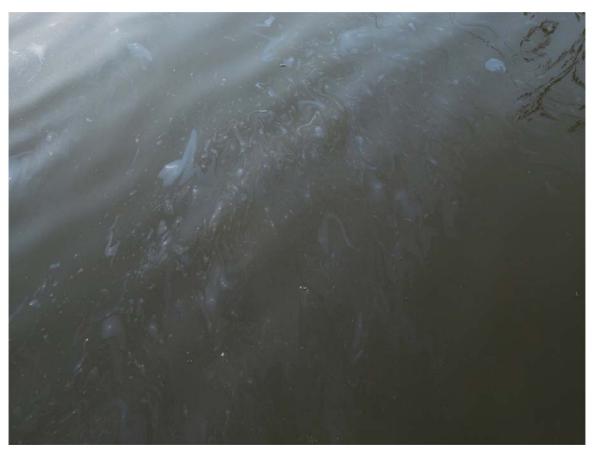
6. MP5.63 LDB area where tar globs, rainbow sheen, and silver sheen were observed.

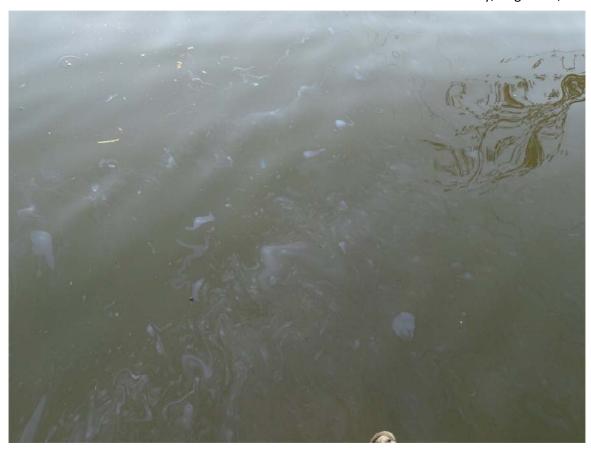
7. MP5.63 LDB tar globs and silver sheen were observed.

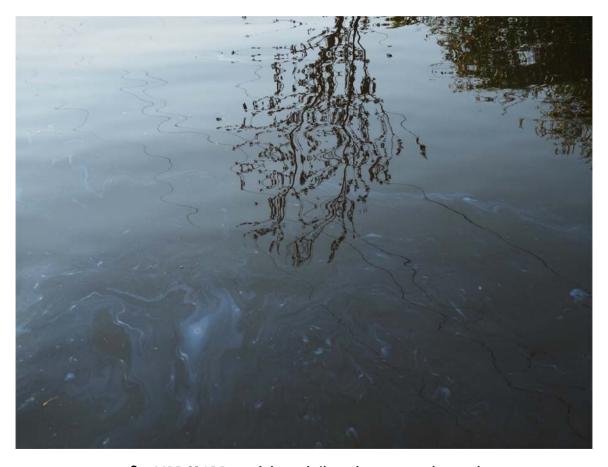
8. MP5.63 LDB tar globs and silver sheen were observed.

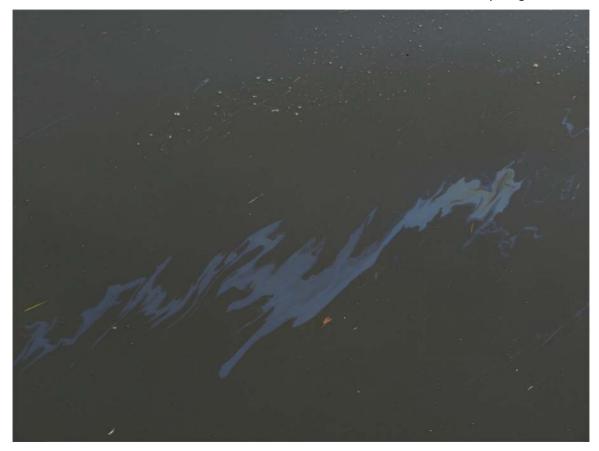
9. Sheen observed collecting along the control point boom at Ceresco Dam.

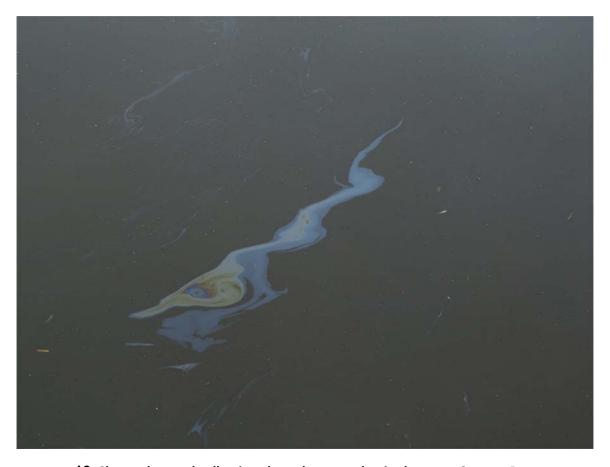
10. Sheen observed collecting along the control point boom at Ceresco Dam.

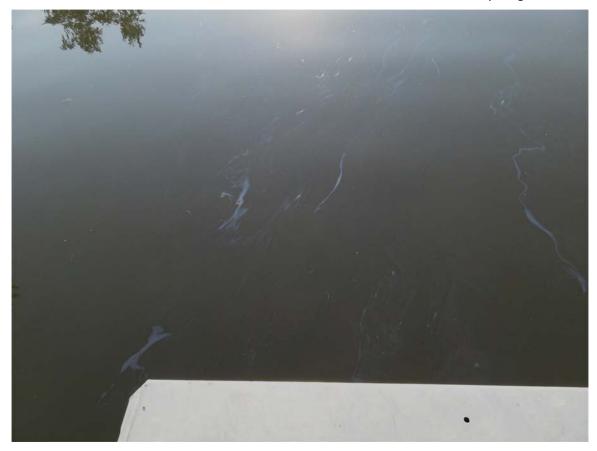
11. MP5.75 RDB sheen observed.

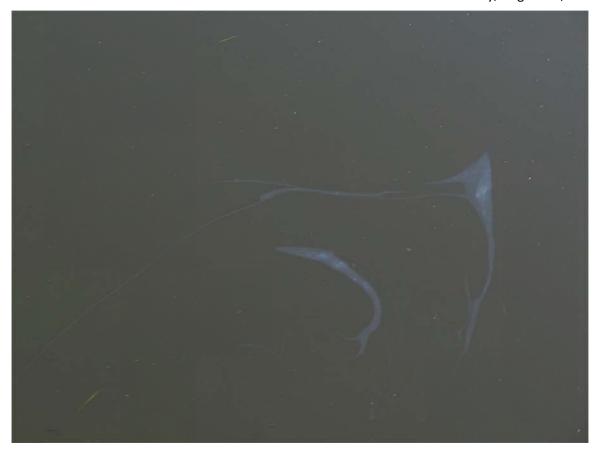
13. MP5.0 RDB observed sheen and tar globs.

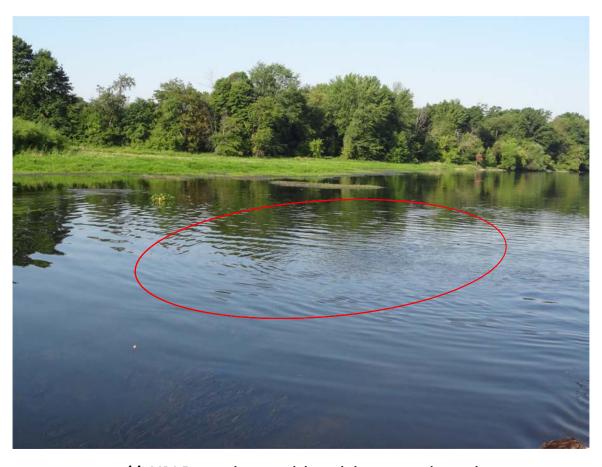
14. MP4.5 area where tar globs and sheen were observed.

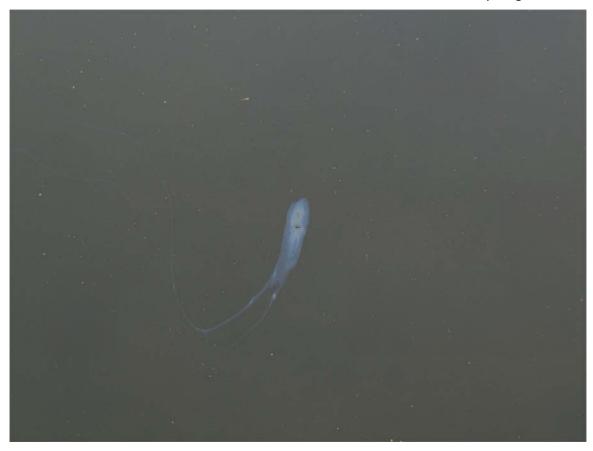
15. MP4.5 tar glob and sheen observed.

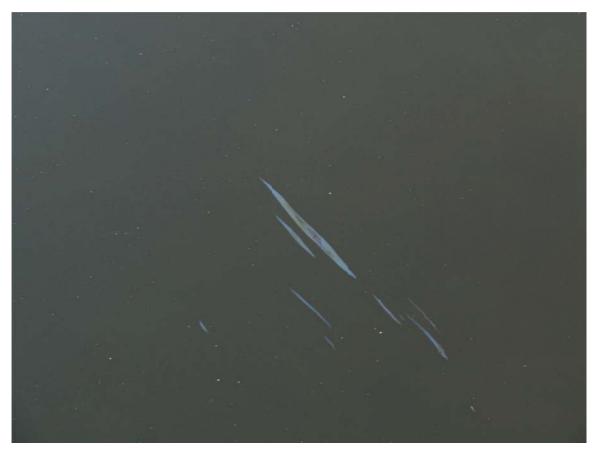
16. MP4.5 tar glob and sheen observed.

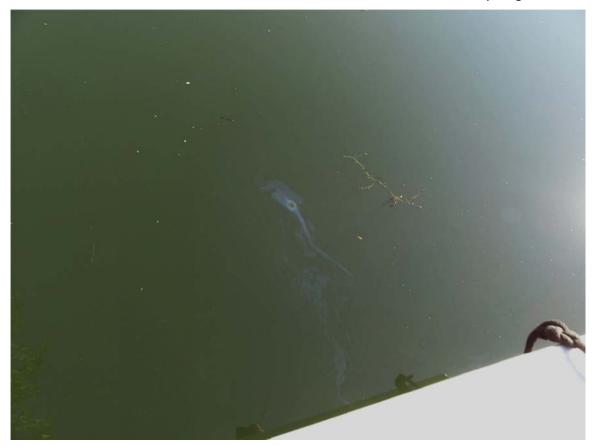
19. MP15.6 LDB observed tar globs and sheen.

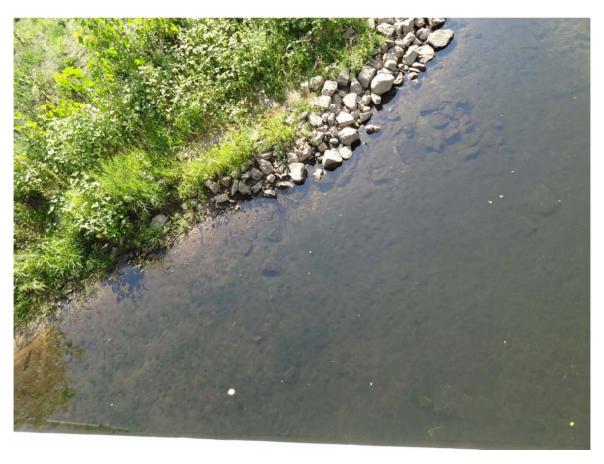
20. MP21.5 Custer Bridge observed sheen however quantity of sheen would not warrant a sweep boat.

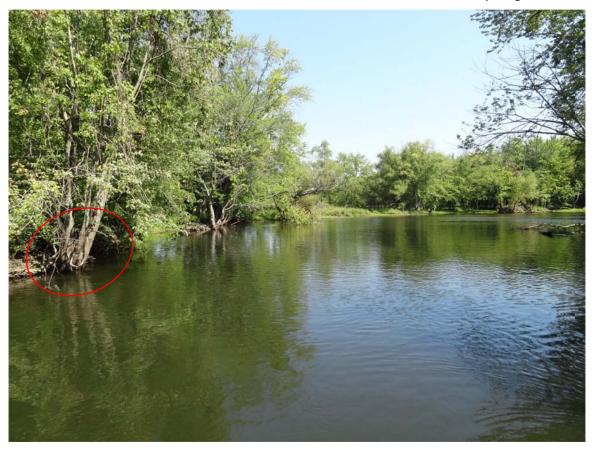
23. MP33.1 RDB smelled oil and investigated the area. Observed rainbow sheen within tree roots.

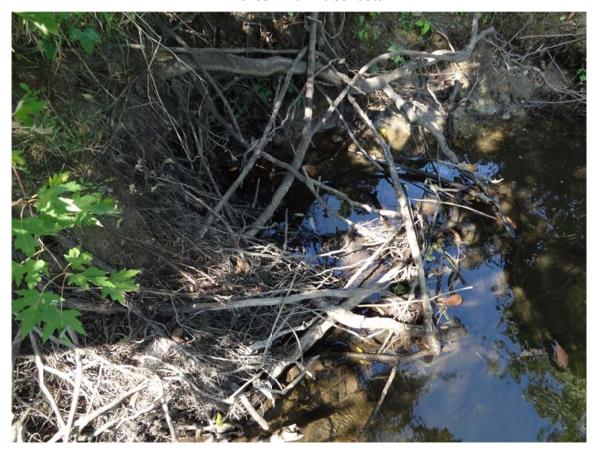
24. MP33.1 RDB smelled oil and investigated the area. Observed rainbow sheen within tree roots.

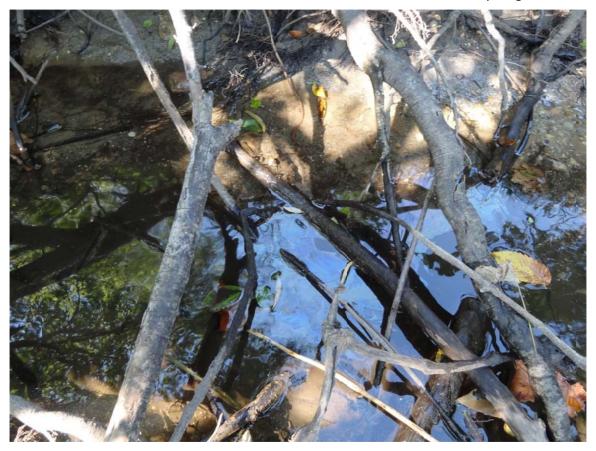
25. MP33.1 RDB smelled oil and investigated the area. Observed rainbow sheen within tree roots.

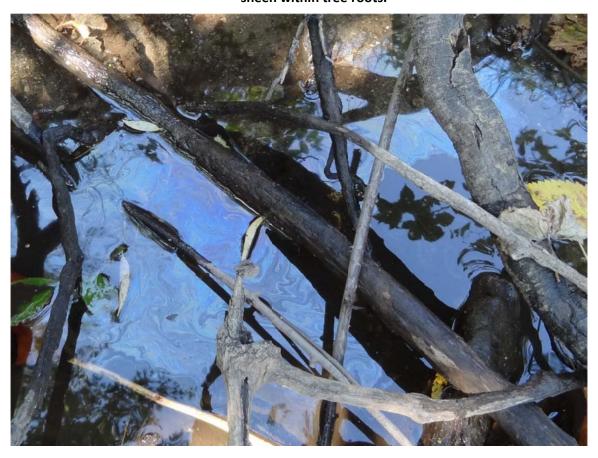
26. MP33.1 RDB smelled oil and investigated the area. Observed rainbow sheen within tree roots.

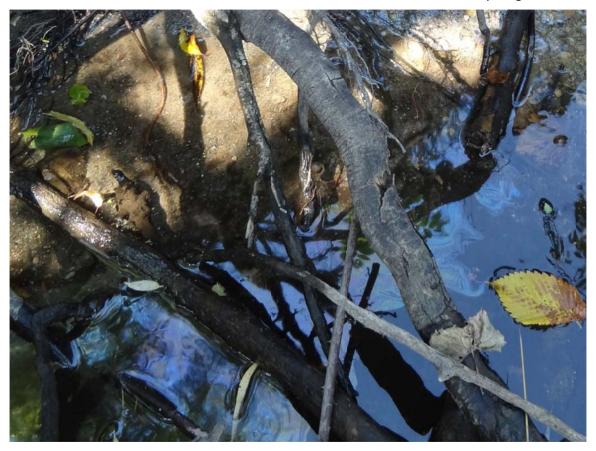
27. MP33.1 RDB smelled oil and investigated the area. Observed rainbow sheen within tree roots.

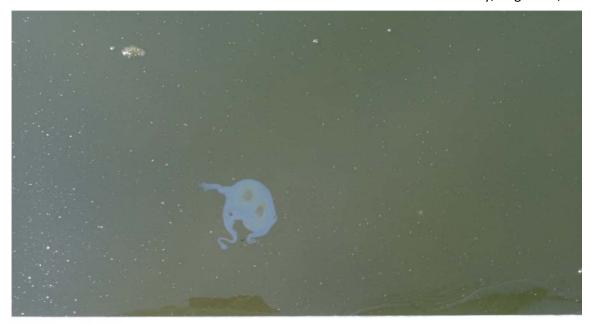
29. Morrow Lake MP38.25 RDB observed sheen and tar globs.

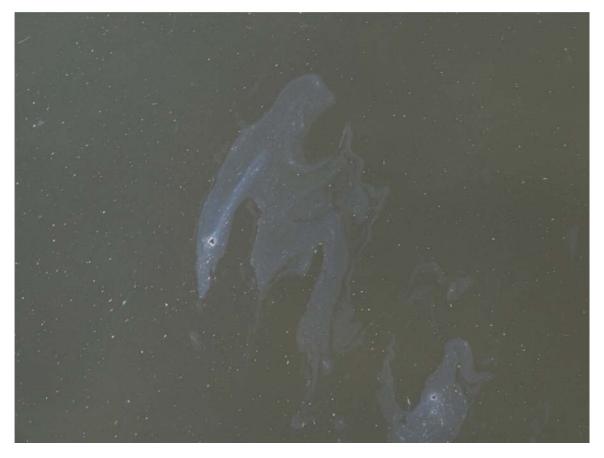
30. Morrow Lake north cove observed sheen and tar globs.

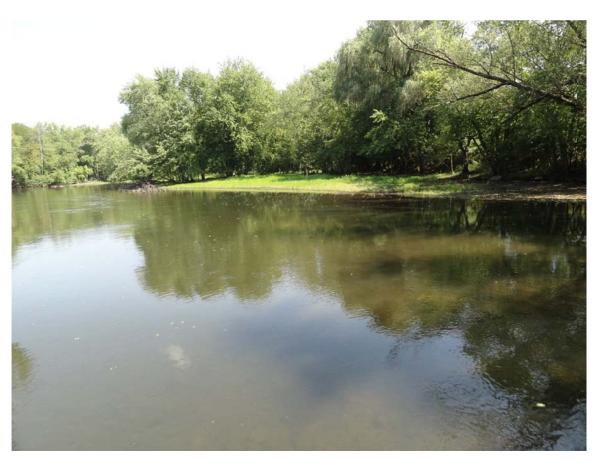
34. MP24.75 LDB sheen observed.

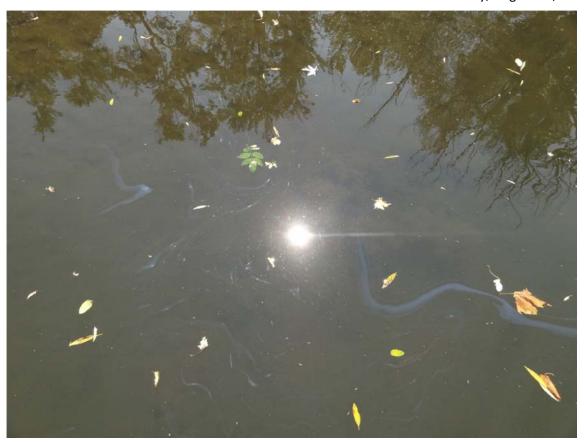
35. MP24.75 LDB sheen observed, however, the quantity of sheen did not warrant a sweep boat.

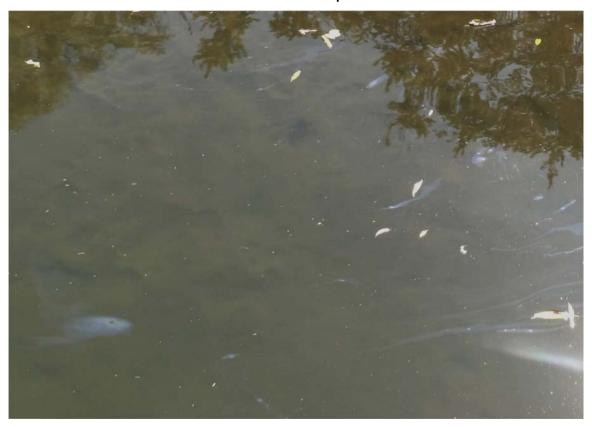
36. MP24.75 LDB sheen observed, however, the quantity of sheen did not warrant a sweep boat.

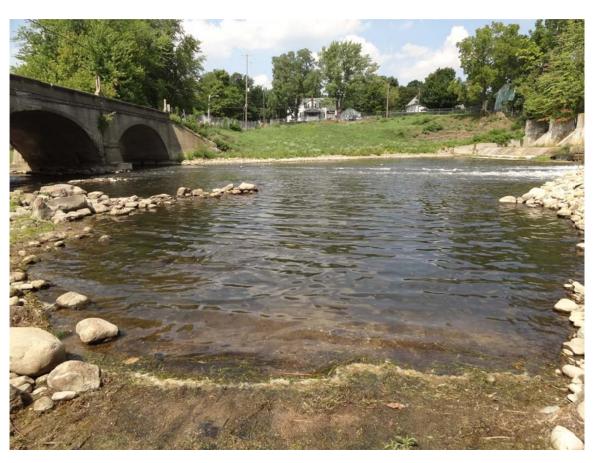
38. Observed sheen and tar globs within the Ceresco Dam downstream portage.

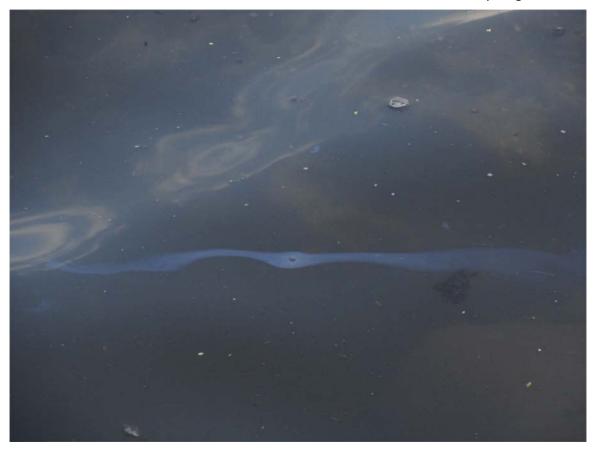
39. Observed sheen and tar globs within the Ceresco Dam downstream portage.

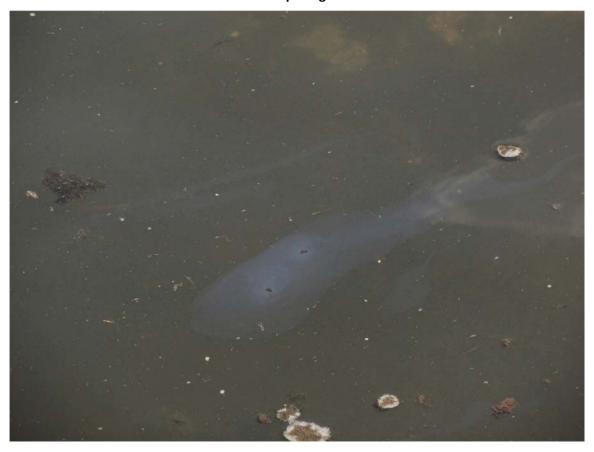
40. Observed sheen and tar globs within the Ceresco Dam downstream portage.
